UNDERWATER BRIDGE INSPECTION REPORT

STRUCTURE NO. 05521

MISSISSIPPI RIVER

DISTRICT 3 - BENTON COUNTY

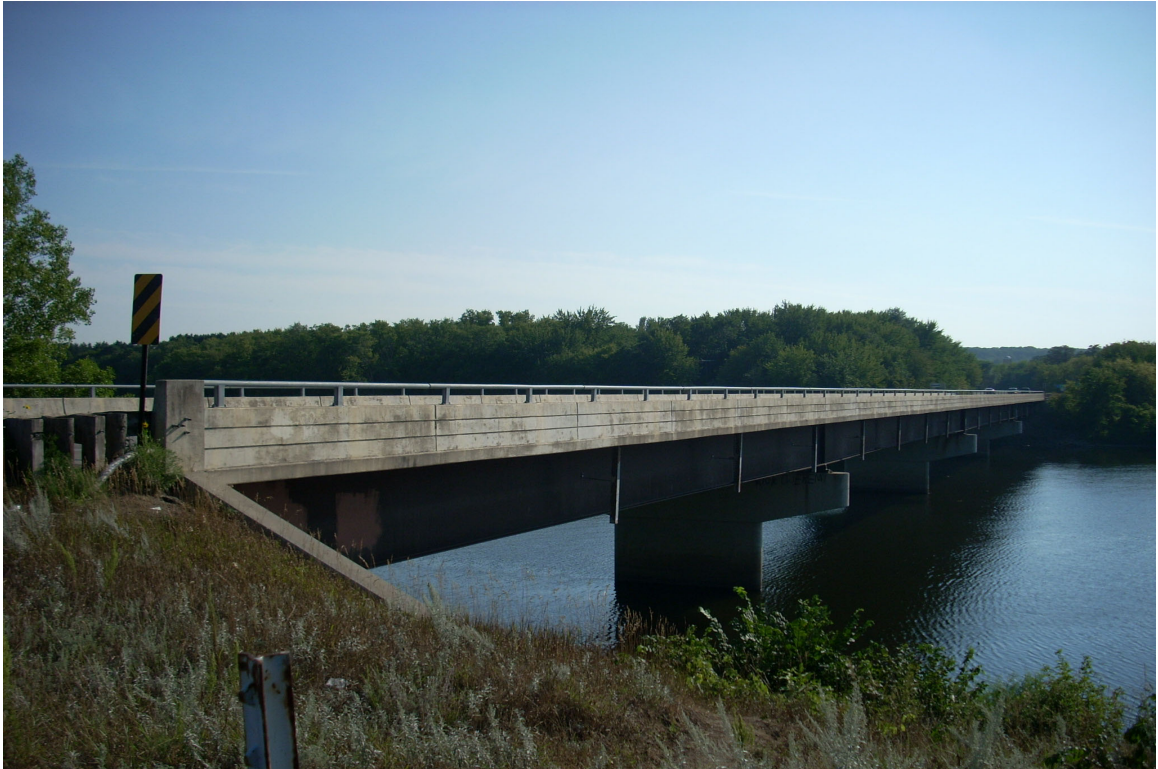
Photograph 1. Overall View of the Structure, Looking Southwest.

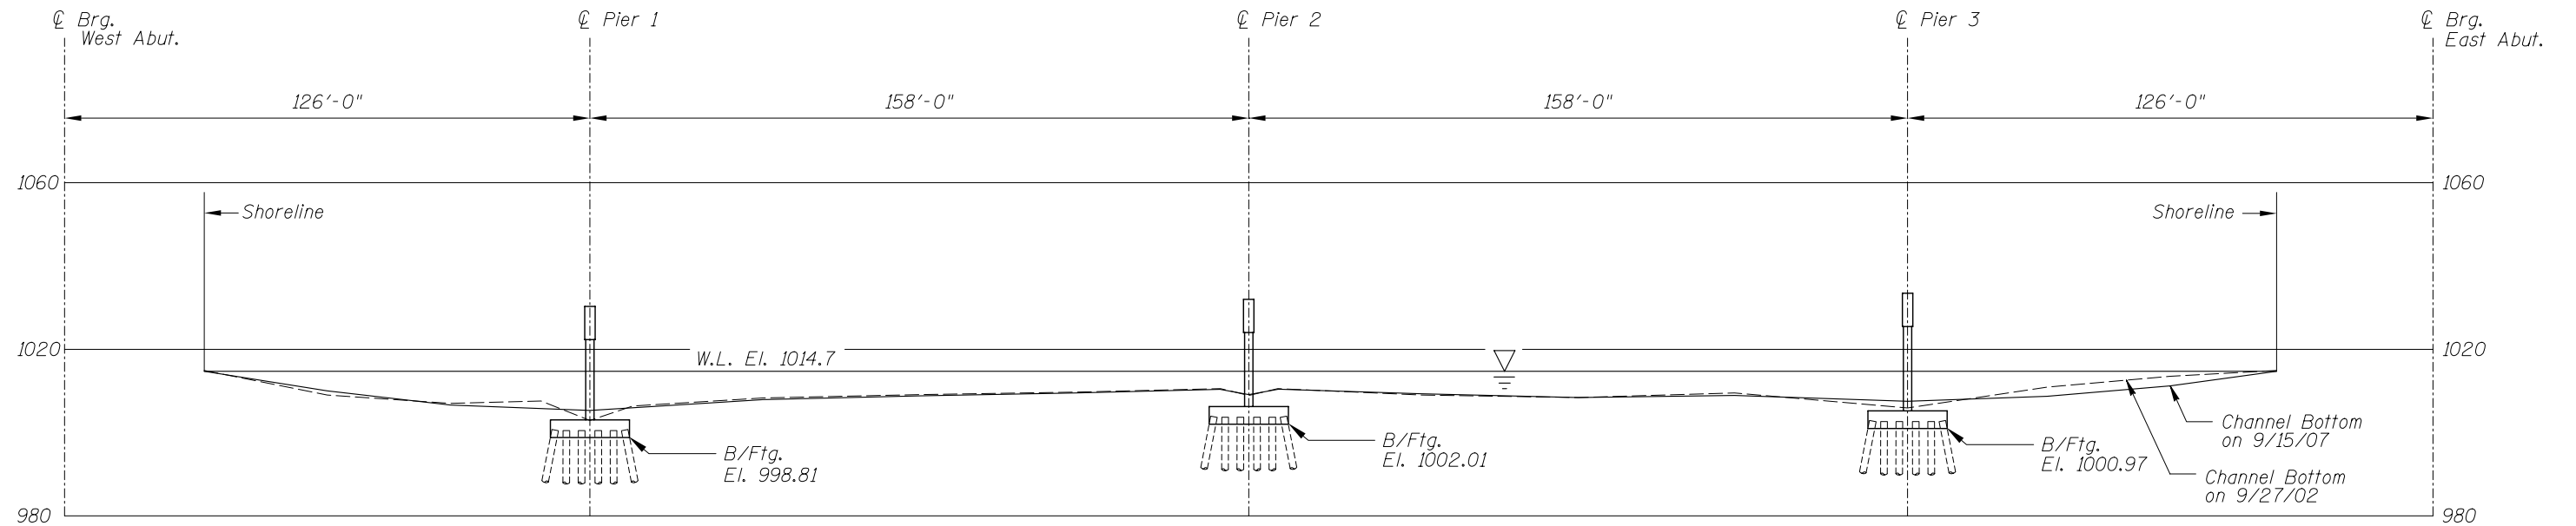
UPSTREAM FASCIA PROFILE

- 1 A band of minor scaling was observed at all piers from 3 feet above to 3 feet below the waterline, with typical penetrations of 1/8 inch and a maximum penetration of 1/4 inch, with heaviest deterioration at the upstream nose.
- 2 The channel bottom consisted of sandy gravel and up to 5-inch-diameter cobbles with a maximum probe rod penetration of 4 inches.
- 3 A 2-foot-radius, 1-foot-deep scour pocket with a minor accumulation of timber debris was observed at the upstream end of Pier 2.
- 4 Above and below band of scaling concrete was smooth and sound.
